# Indication of Partial Discharges

## FAILURE DETECTION SYSTEM ON MEDIUM VOLTAGE INSULATED OVERHEAD LINES

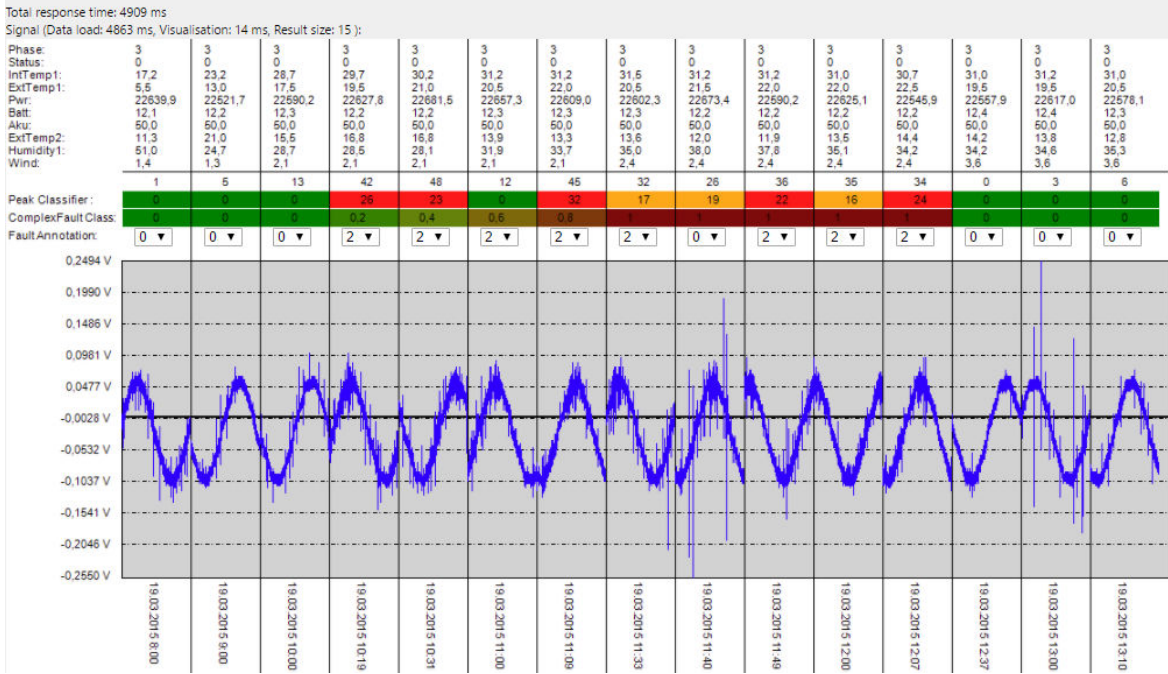
Measured signal in Volts and classification of the probability of failure.

A typical fault detected by iPD can be divided into three stages to present to the dispatcher:

- Beginning of the fault (e.g. a tree branch fell on the conductor, start of the degradation, number of peaks 26 – probability 20%).
- Ongoing fault (increased number of contacts, number of peaks 32, probability 80-100%).
- End of fault (line back in normal operation, number of peaks 0, probability 0%).

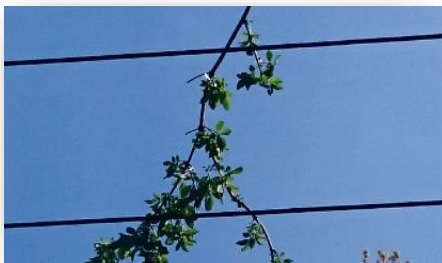
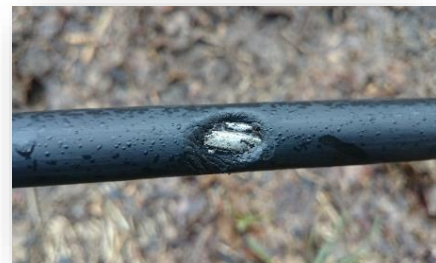
Top pictures: Example of signal (green without fault, red with fault),  
Bottom pictures: typical fault cause (fallen tree branch) and result (damaged insulation).
